Unexpected Voids

Lessons Learned: Unexpected Voids

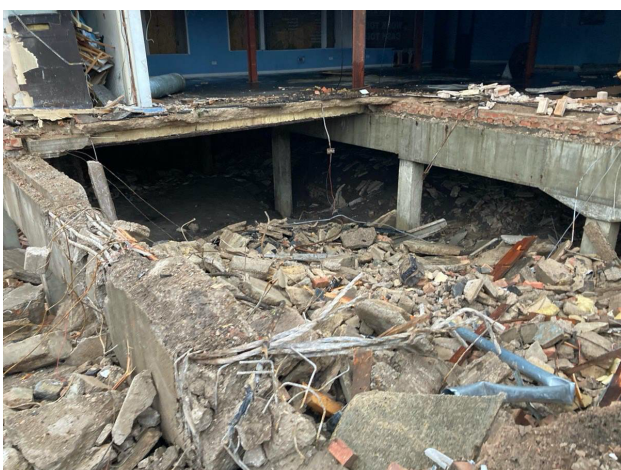
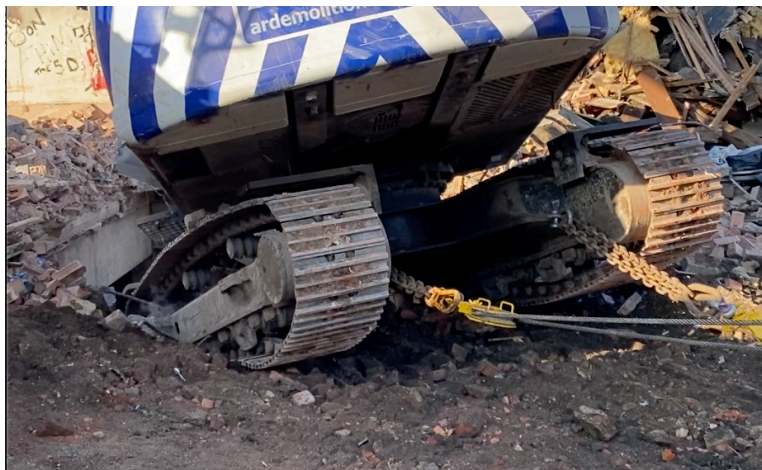
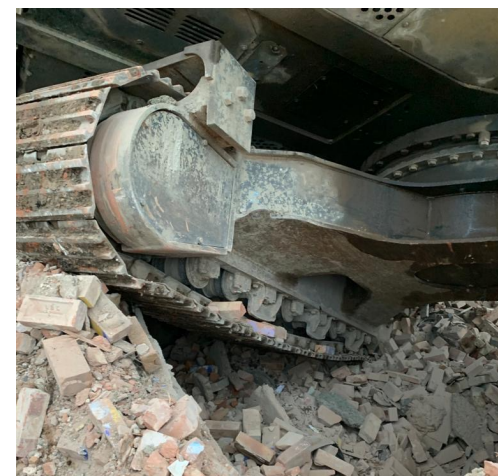
An unfortunate incident occurred involving the collapse of a ground floor slab after a demolition rig tracked above an unknown void. **Thankfully no one was injured**, however the incident serves as a stark reminder of the inherent dangers within demolition works.

A full investigation is ongoing into the incident. Early findings outline that the structure had been constructed on columns with a suspended ground floor slab, creating a **tapered void** measuring at various depths ranging from appx 0.1m to 3m across opposite ends of the structure.

The structure itself, the site features and the adjacent areas around the structure also did not indicate the presence of the void or any varying ground levels beneath the ground floor slab.

Whilst **Ground investigation reports** had been produced for the site (including physical bore holes samples) these were taken around the structure. The results of which **did not indicate the presence of any void**. In addition, the underground void was **not identified on any site drawings**, reports or information.

Site inspections prior to the works also failed to identify any normal signs or indication of the presence of the underground void. e.g. service hatches, service runs, vents or openings.

Prior to the incident areas of the structure above the ground floor slab had been demolished and tracked over, without incident or indication that the slab was suspended. This **area had been checked by the plant operator** which was clearly proved to be ineffective.

- Whilst a degree of information was available prior to this incident, it is common place in demolition to have **little or no historic information** on the structure or site. As demolition professionals we need to educate and advise **Clients / Principal Designers** of the level of information and surveys required for our works to be designed and delivered safely.

- Whilst visual & physical investigations, surveys and inspections of the structure are a vital control, the use of further tools such as GPR should be used more common place.

- The physical marking out and exclusion around underground hazards are a key final barrier in avoiding collapses and should be adopted at all times.
- Intrusive or physical checks should be undertaken by plant operators to assess the ground prior to tracking over new or changing areas of a structure.
